NASA CR-241

**OPERATION OF A FORCED CIRCULATION,
HAYNES ALLOY NO. 25, MERCURY LOOP
TO STUDY CORROSION PRODUCT
SEPARATION TECHNIQUES**

by David B. Cooper

Prepared under Contract No. NAS 5-462 by
THOMPSON RAMO WOOLDRIDGE, INC.
Cleveland, Ohio
for

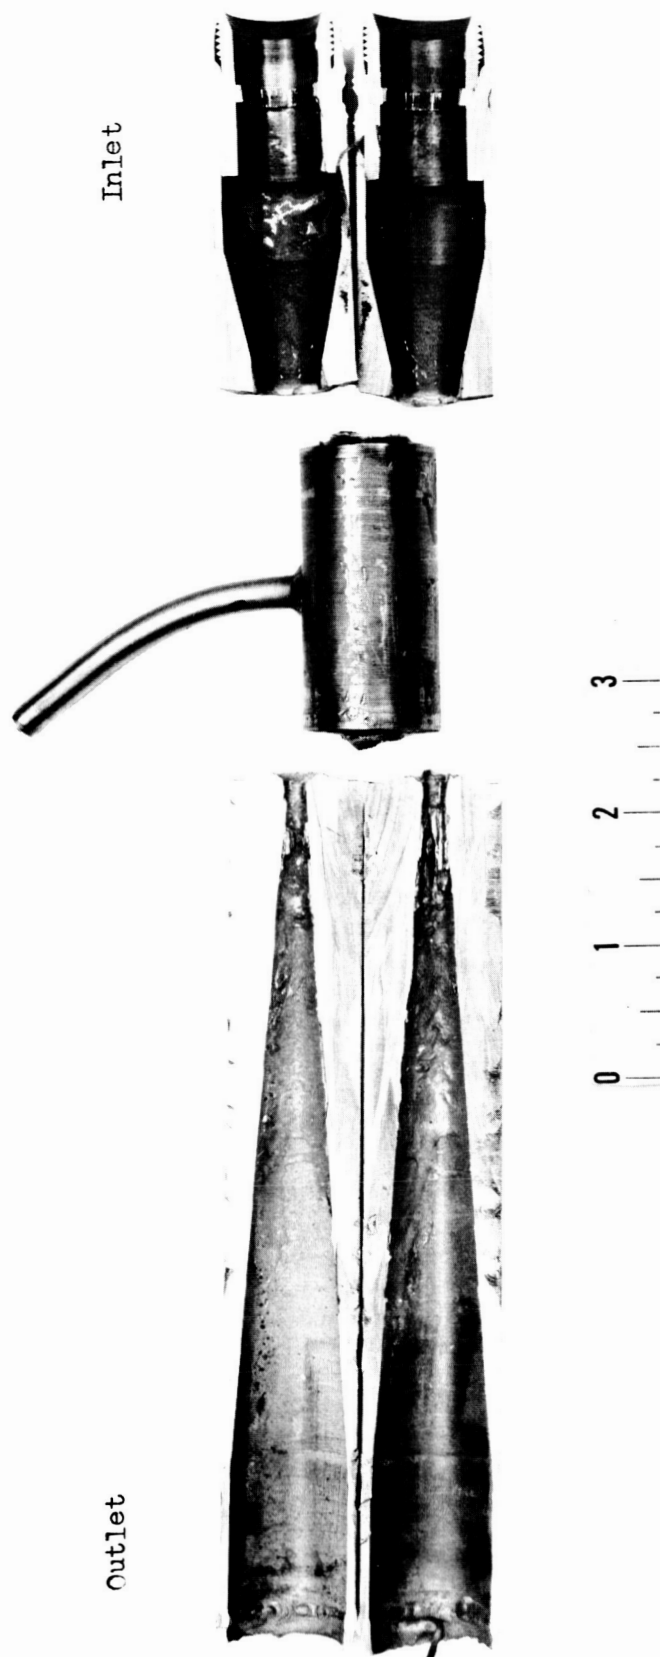
Figure 11. Deposition in Venturi.

As shown in Figures 11 and 12, the Venturi was found to contain an amalgam which was located on the outlet side in the vicinity of the orifice. The pre-heater (Sections 10, 11, and 12) also contained an amalgam, as shown in Figure 13. Photographs of the boiler are shown in Figure 14. As seen here, the boiler inlet contained a small quantity of a dark deposit while the mid-section and outlet again contained an amalgam. The amalgam extended into the superheater inlet, as shown in Figure 15. From this point on, as the mercury was dried and superheated, the quantity of deposit decreased until the superheater outlet was reached, where an amalgam was again present. The vapor corrosion product separator outlet tube and the superheater mid-section were essentially free of deposit, Figure 15.

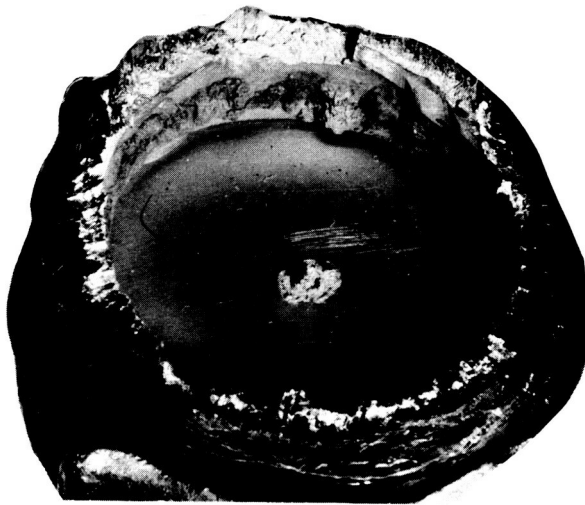
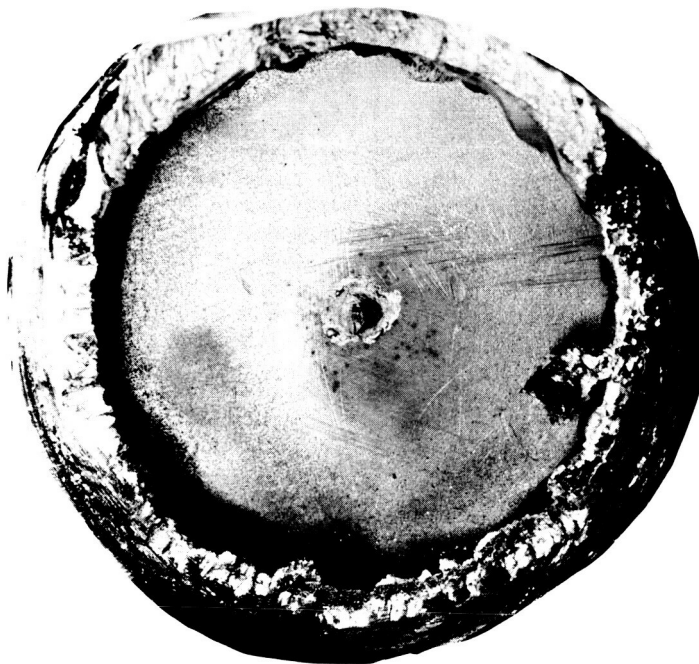
Figure 16. Deposit Found in Loop Orifice.

A hard deposit was found in the orifice and is shown in Figure 16. The deposit contained essentially no mercury and was blocking approximately 99.2 percent of the flow passage. The presence of this deposit accounts for the decrease in flow rate in the system during the final hours of operation. However, it is believed that the majority of this deposit was formed during the shut-down operation, since the change in flow rate did not reflect essentially complete blockage.

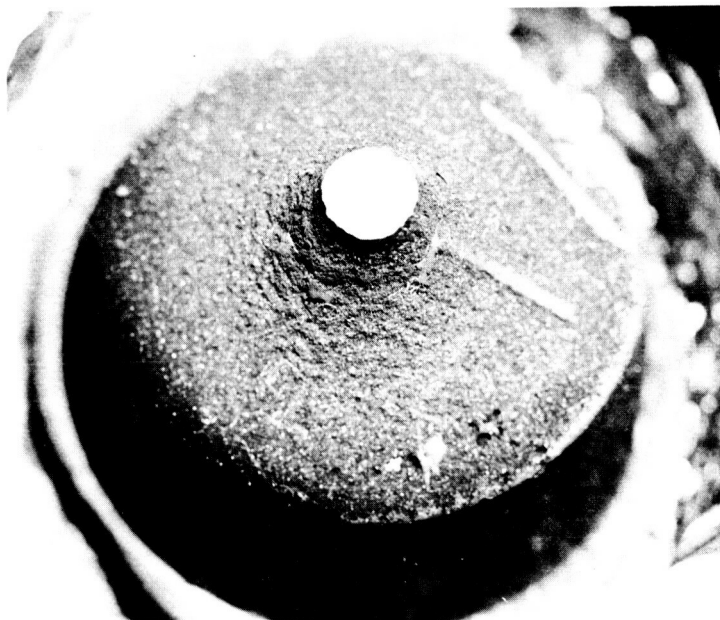
Figure 17. Deposit Found in Loop Nozzle.

The nozzle was also observed to contain a deposit, as shown in Figure 17. Although there was a small amount of deposition on the inlet side, the majority of the deposit was found on the outlet.

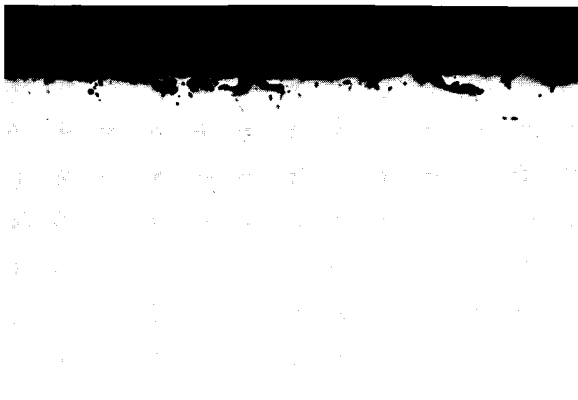
a) Section 12, TC 2 Pre-Heater Inlet
(Crevice Attack)

Corrosion in the horizontal pre-heater inlet section of the loop was manifested as crevice attack up to 1.85 mils deep. A typical photomicrograph is shown in Figure 20a. The average wall temperature at this section was measured at 838°F. Swirl wire attack was less severe, 0.55 mils, Figure 23a and Table 3. The attack was similar to the container wall attack (i.e., crevice type).

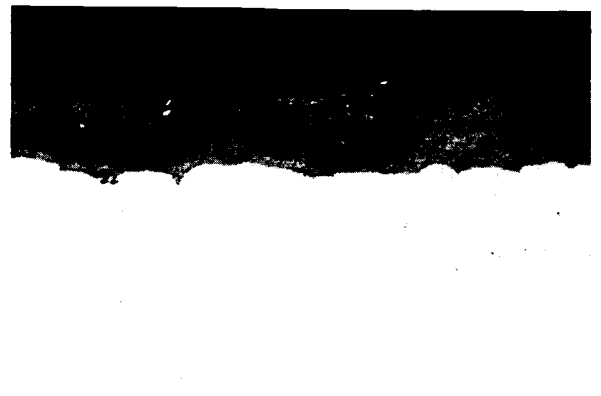
b) Section 10, TC 6 Pre-Heater Outlet
(Layer Attack)

The pre-heater outlet section suffered the most serious attack observed in the loop (see Figure 20b), and was as great as 10 mils in the 1106°F region, Table 2. Attack was of the leached zone type. Swirl wire attack was again considerably less severe (2.8 mils) than the corresponding wall attack and is represented by Figure 23b.

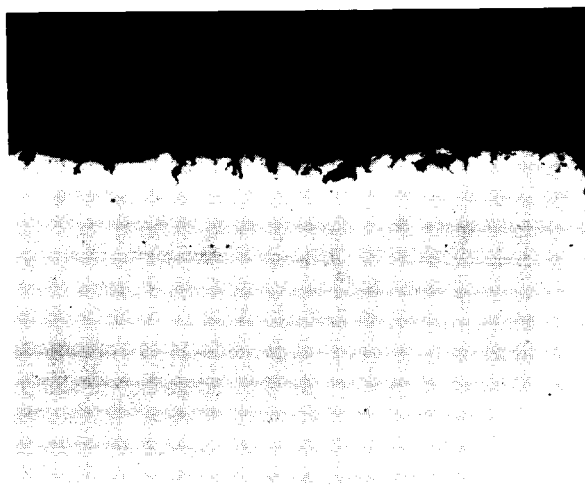
d) Vapor Corrosion Product
Separator Filter Tube
(Crevice and Intergranular Attack)

The vapor corrosion product separator was attacked to a depth of 1.9 mils in the 1130°F temperature zone. Corrosion was manifested as both intergranular and leached layer attack (see Figure 21d). Attack diminished to 1.1 mils penetration in the superheater mid-section as vapor quality improved, Figure 22a. Corrosion was of the crevice type. In the last quarter of the superheater (outlet), a substantial deposit was observed, Figure 22b. The maximum thickness of this deposit was seven mils. Swirl wire attack in the vapor portion of the loop generally was of the intergranular type and varied between 0.3 and 1.35 mils, Figures 23e and 24b and Table 3. Only the Haynes alloy No. 25 swirl wire in the vapor region contained cracks as contrasted to the lack of cracking in the liquid-contacted sections, Figure 24. The swirl wire was cold-worked as a result of swirl forming.

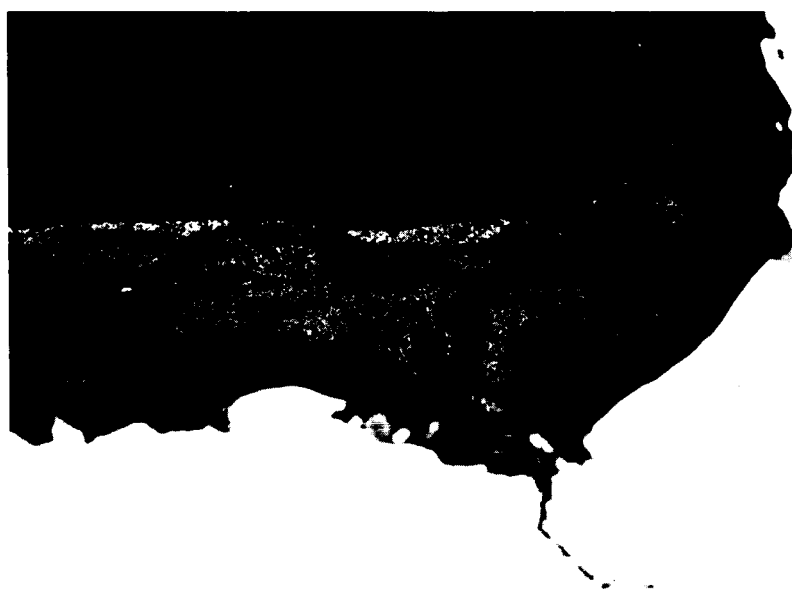
b) At Tube-Orifice Plate Junction

Figure 26. Cross-Section of Orifice on Inlet Side Showing Intergranular Attack Near Orifice Opening and a Leached Layer and Cracking at the Orifice Plate-Tube Junction. Magnification: 250X, Unetched.

Orifice corrosion was greatest on the inlet side near the wall and measured 7.3 mils in depth, Figure 25. Cracking was also observed at the orifice plate-tube wall junction, Figure 26b. Corrosion up to 1.1 mils in depth was also present on the orifice opening, Figure 26a. The corrosion was manifested as both layer and intergranular attack. The outlet side of the orifice contained deposits which adhered to the orifice wall. The attack was undoubtedly a result of mercury vapor condensation on the orifice plate, since immersion thermocouples recorded 796 and 867°F as the respective inlet and outlet temperatures. The severity of the attack could also be a result of erosive action by the condensing mercury vapor, which is not readily separable from corrosive attack.

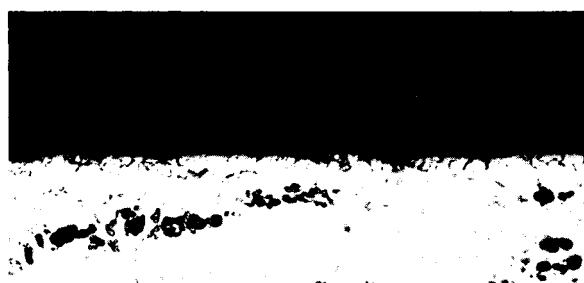
b) Throat Area
(Intergranular Attack)

Examination of the nozzle throat specimen (see Figure 27b) revealed a surface zone of intergranular precipitation extending to a depth of approximately 70 microns. A series of large gray precipitates near the base metal-end of the surface zone were also noted. The gray phases and oxides were found to be zirconium oxides that appeared to also contain some nickel in solution. These phases were identified as oxides since they yielded a visible fluorescence when struck by the electron beam. This fluorescence is typical of the presence of combined oxygen. The composition of the metal matrix surrounding the oxides was found to be essentially the same as the base metal. The concentration distributions for chromium and tungsten were consistent at less than 0.05 percent.

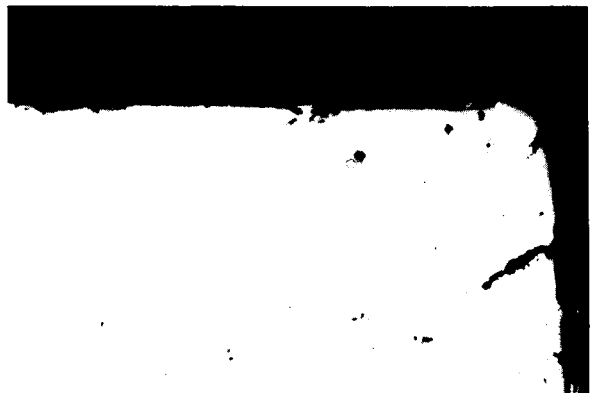
d) No. 3 Nivco 10
(Deposition and
Intergranular Attack)

Corrosion was observed on three specimens, namely Nos. 1, 3, and 4 (Table 4). Corrosion on the PH15-7Mo in condition RH 950 (sample No. 4) was manifested as a leached layer less than one mil deep, Figure 28f. Corrosion on the Nivco 10 was manifested as crevice attack on specimen No. 3 and as intergranular penetrations up to 2.5 mils in depth on specimen Nos. 1 and 3, Figures 28a, 28c, and 28d. Deposits of corrosion products were also evident on Nivco 10 specimen No. 3, Figure 28d.

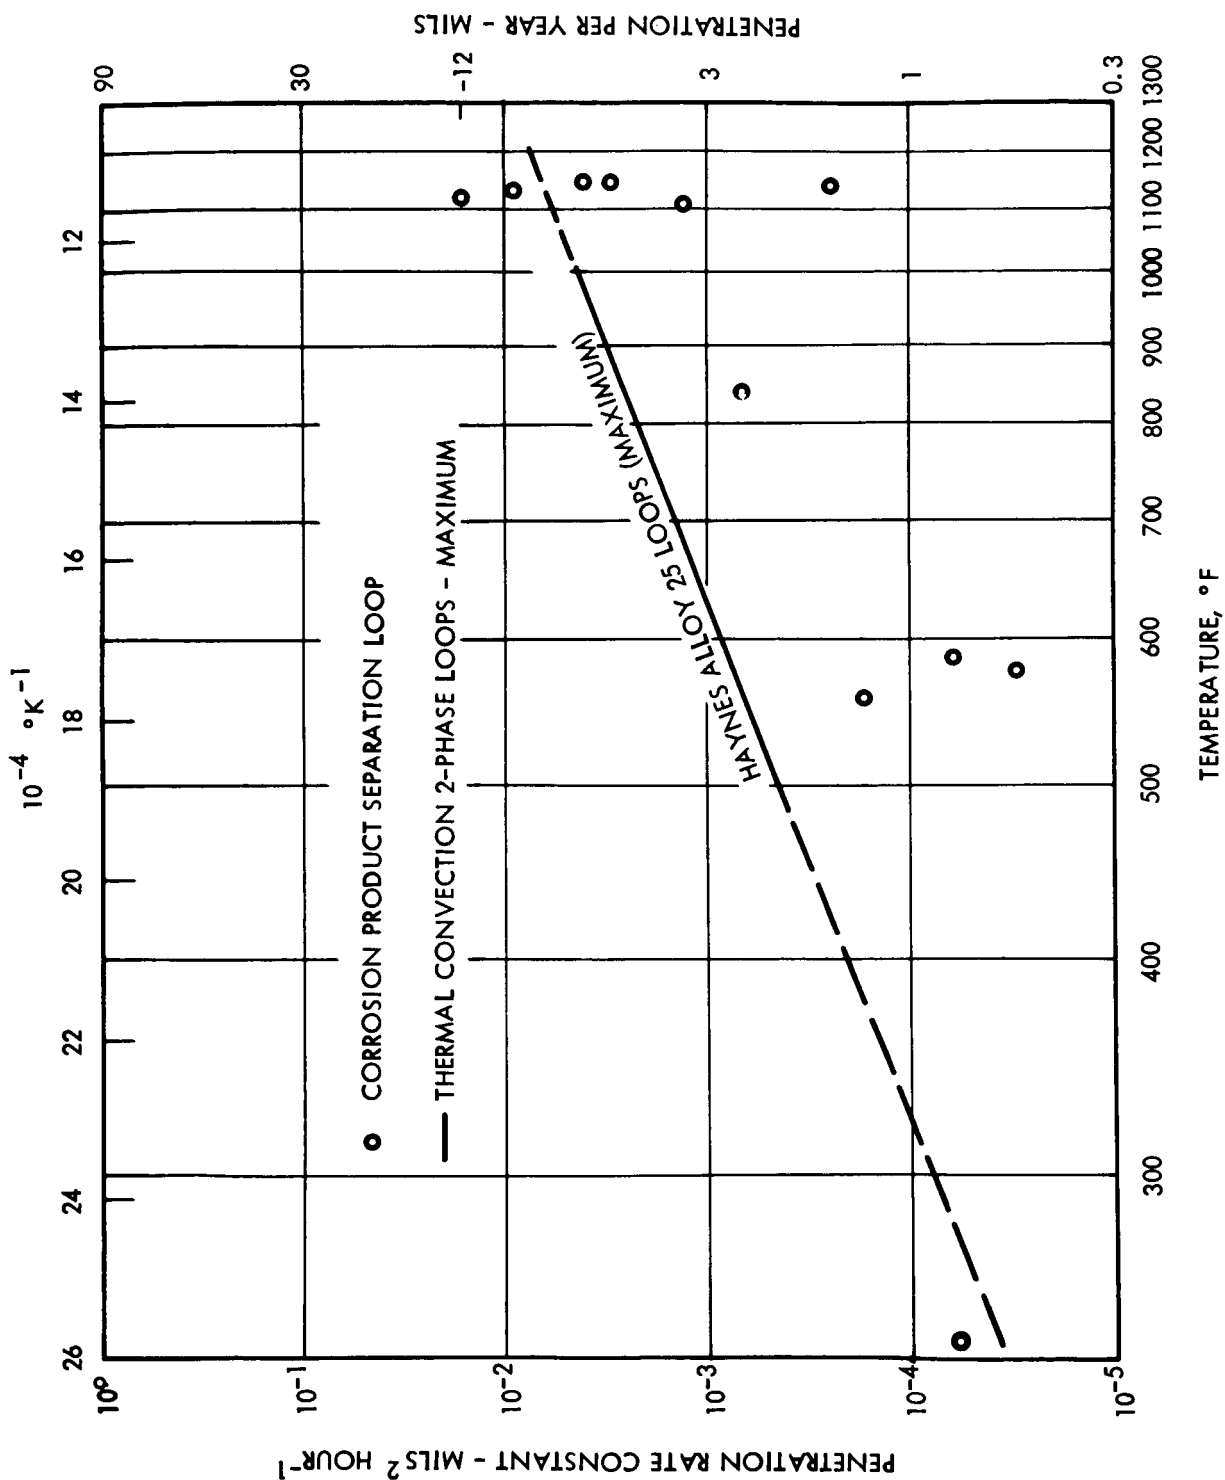
FIGURE 30. COMPARISON OF HAYNES ALLOY NO. 25 MERCURY PENETRATION FROM CORROSION PRODUCT SEPARATION LOOP WITH THERMAL CONVECTION, TWO-PHASE LOOPS (4).

In general, the results indicate that the greatest attack occurred in the low vapor quality regions of the boiling section of the loop and that the attack decreased as the vapor quality increased. Near the outlet of the superheater, where condensation was beginning to take place, deposition was observed. This continued into the region of the orifice and nozzle as the vapor quality continued to decrease. As a result of the increase in liquid content of the vapor, corrosion of the orifice (up to 7.3 mils) and of the nozzle (up to 5.0 mils) occurred. The Nivco 10 and PH15-7Mo erosion specimens also suffered some attack and erosion damage, but this was not severe. Minor attack was observed in the condenser and subcooler.
